磁盒使用后发生退磁现象的原因分析

ANALYSIS OF THE CAUSES OF DEMAGNETIZATION AFTER USE OF THE SHUTTERING MAGNET

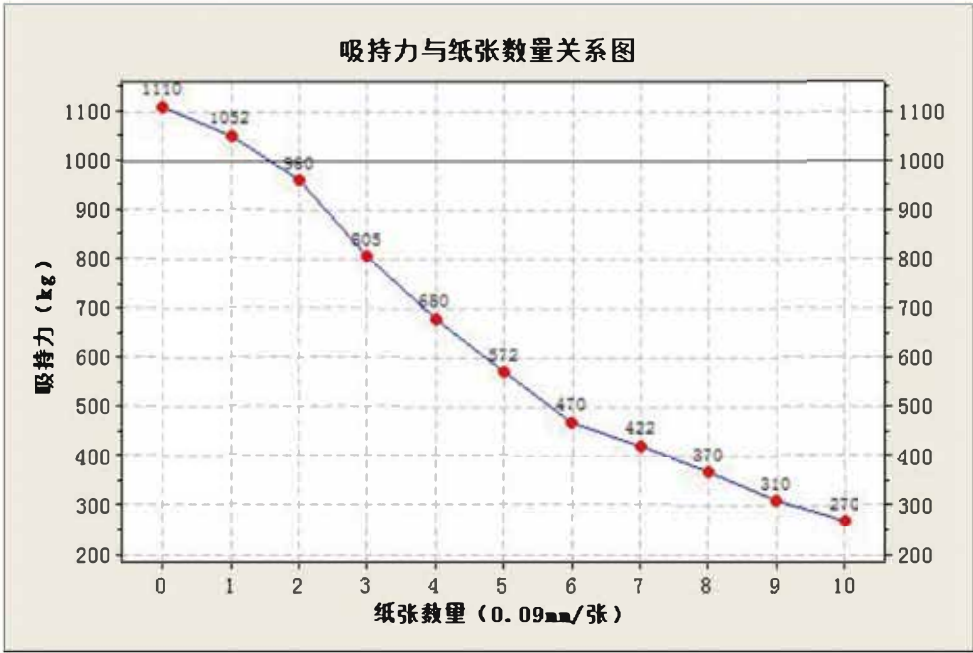
When using the Shuttering Magnet, it is essential to ensure that there is no debris at the bottom, as this can adversely affect its adsorption force with the mold platform. In its operational state, the adsorption surface at the bottom of the magnetic block fits tightly against the steel mold platform, ensuring a strong hold. However, the presence of foreign objects—such as concrete, grease, or film—between the magnetic block and the platform can prevent a secure fit, significantly reducing the adsorption force. To illustrate this, we used our company's QCM-1000B model magnetic box to investigate the relationship between adsorption force and the gap between the bottom of the magnetic block and the platform. We placed between 0 to 10 A4 sheets of paper (each with a thickness of 0.09 mm) between the bottom of the magnetic block and the platform to measure the adsorption force of the Shuttering Magnet at various gap sizes. The test data is as follows:

As illustrated in the figure above, the gap between the bottom of the magnet block and the platform significantly influences the pull force of the shuttering magnet. Therefore, we recommend that customers conduct daily maintenance on the shuttering magnet.

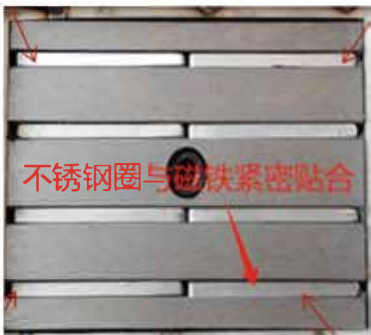
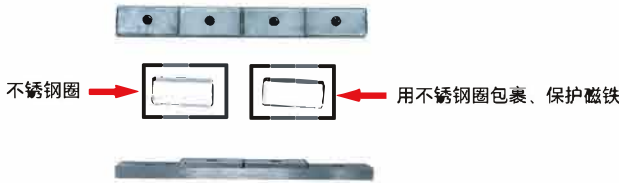
On the other hand, the structure of the magnetic block itself can lead to uneven magnetic surfaces if the production process is not meticulously controlled. The magnetic block is assembled using NdFeB magnets and iron bars connected by bolts. If the size and positioning of the screw holes are not accurately managed, the overall surface of the iron bars may become uneven after assembly, necessitating smoothing with a grinder. During operation, the screw rod that passes longitudinally through the middle iron bar exerts a pulling force on the entire magnetic block. If the size tolerance of the hole is excessively large, a gap may form between the screw rod and the horizontally positioned iron bar, resulting in misalignment of the iron bars. This misalignment can lead to an uneven overall magnetic surface, significantly affecting the pull force of the magnetic block. To ensure optimal assembly of the magnet and iron bar into a magnetic block, it is crucial that the magnet surface is positioned as low as possible relative to the plane of the iron bar. This positioning helps to prevent collisions. Additionally, the magnet requires a protective layer to guard against damage and corrosion. To protect the magnet, our company employs advanced technology to affix a stainless steel ring to each magnet, ensuring a tight fit through welding and mechanical fastening.
